Disenchantment Bay-N, SE09-06

Geographic Response Strategies for Southeast Alaska Subarea, Zone 9

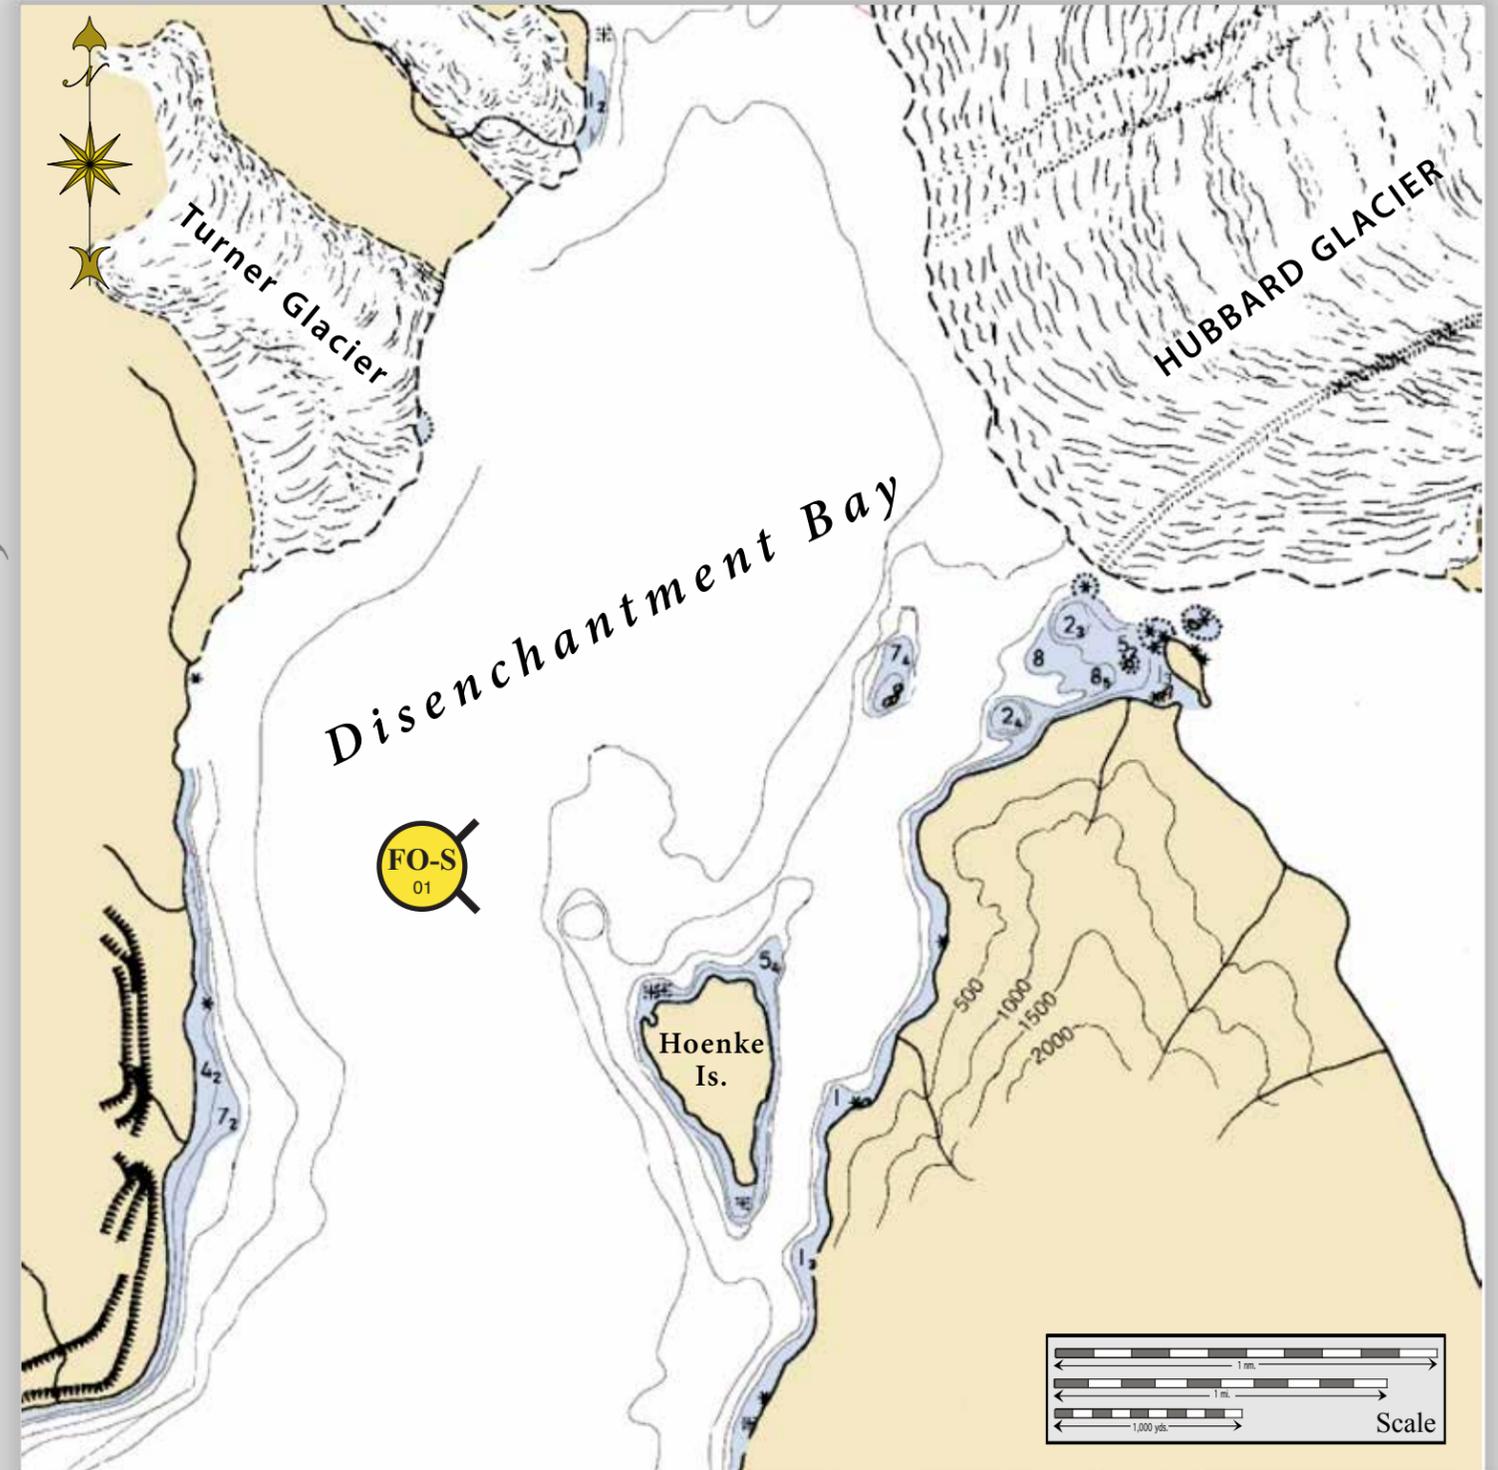
Center of map at 59° 58.28' N Lat., 139° 34.44' W Lon.

Disenchantment Bay Nearshore waters in the general area of: Lat. 59° 58.15'N Lon. 139°35.03'W	Free-oil Recovery Maximize free-oil recovery in the offshore & nearshore environment of Disenchantment Bay depending on spill location and trajectory.	Deploy free-oil recovery strike teams upwind and up current of Disenchantment Bay. Use aerial surveillance to locate incoming slicks.	Deploy multiple free-oil recovery strike teams as required to maximize interception of oil before it impacts sensitive areas.	Vessel Platform	Via marine waters Chart 16761	Fish- coho, sockeye Birds- shorebird concentrations, waterfowl concentrations, seabird nesting Marine Mammal - harbor seal pupping area Habitat- sandy beach, gravel beach, exposed tidal flats Human Uses – subsistence, tourism	Vessel master should have local knowledge. Use extreme caution, shoal waters with numerous reefs and rocks, shallow mud flats and channels. Glacial ice may impede operations. Consult the ADEC “Spill Tactics for Alaska Responders” manual for additional information on the deployment of these tactics. Site surveyed: not surveyed Tested: not yet
